Forensic Assessments of the Nuclear Propulsion Plants of the Submarines HMS *Tireless* and RF Northern Fleet *Kursk*

John H Large

Large & Associates, Consulting Engineers

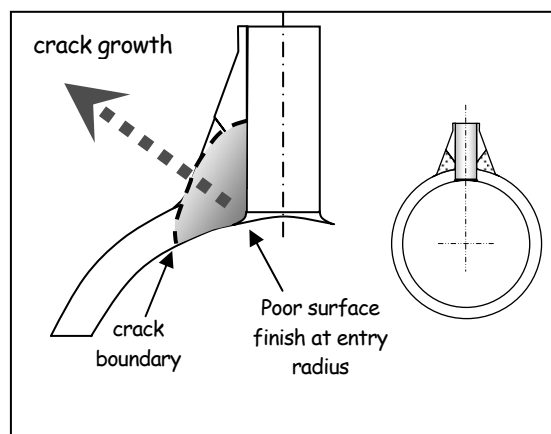
6 Pressuriser Surge Line Pintle showing 1 of 2 thermally induced cracks

the cracked junction to be trepanned out resulting in the need for a complete in situ reconstruction of the surge pipe junction.

CNNRP concluded upon fuller inspection of the removed trepanned section, the cracking to have arisen from thermal fatigue resulting from slugs of cooler water cycling in and out of the mouth of the pressuriser surge pipe⁸ over many years of operation, although the final detailed results of the analysis of the removed pintle-main pipe section were never revealed to the Expert Panel advising the Government of Gibraltar.⁹ In the absence of proof otherwise, it may have been that the failure cause was more complex, resulting from a combination of thermal fatigue¹⁰ and thermal striping,^{11,12} the latter being relatively short-term in development. Another possible contributory factor to the cracking was the very poor (grooved) finish of what should have been a smooth, radius edge of the main pipe cut-out leading into the surge pipe, possibly containing latent crack initiators that could have developed over years of service.

Working up the new repair plan and the decision to replace the pintle design with a one-piece forged swept branch connector (a *Sweepolet*) further delayed progress on *Tireless* until November, thereafter there was stay-over whilst another *Trafalgar* class submarine was adopted as the lead boat to demonstrate the ease and validity of repair at the fully equipped Devonport Dockyard in the UK. *Tireless* was eventually fitted with the *Sweepolet*, passed NDE and the cold hydro test, being readied for nuclear power operations to leave the Port of Gibraltar on 8 May 2001, almost a year to the day that she ignominiously limped into Gibraltar under her emergency diesel power.

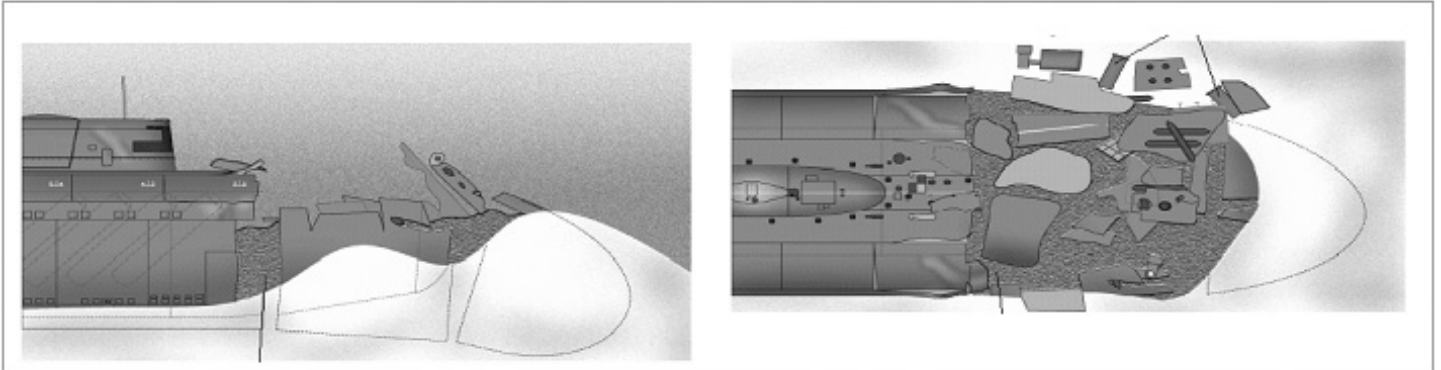
forward pressure hull (10 x 8m area) and outer casing and, at the same time, sending a reverberating hammer blow through the compartments towards the stern. Structural and flood bulkheads N° 2 and 3 were ripped through, with N° 4 buckling and subsequently collapsing under the hydrostatic flooding loads. N° 5, the forward reactor compartment bulkhead, and the remaining bulkheads through to the ninth compartment remained intact.¹⁵

7 Wreck of the *Kursk* – bow flood hull housing the forward seeking sonar has been displaced, the various cylinders are gas storage bottles, and the entire top section of the pressure hull of No 1 and No 2 compartments has been blown away
